**POTENTIALLY RESPONSIBLE PARTIES (PRP) OVERSIGHT REPORT
FOR
SAN JACINTO RIVER WASTE PITS SITE
HOUSTON, HARRIS COUNTY, TEXAS**

U.S. Environmental Protection Agency Region 6
1445 Ross Avenue
Dallas, Texas 75202

June 7, 2010

Dynamac Corporation
1202 Executive West
Richardson, Texas 75081
(214) 575-3344

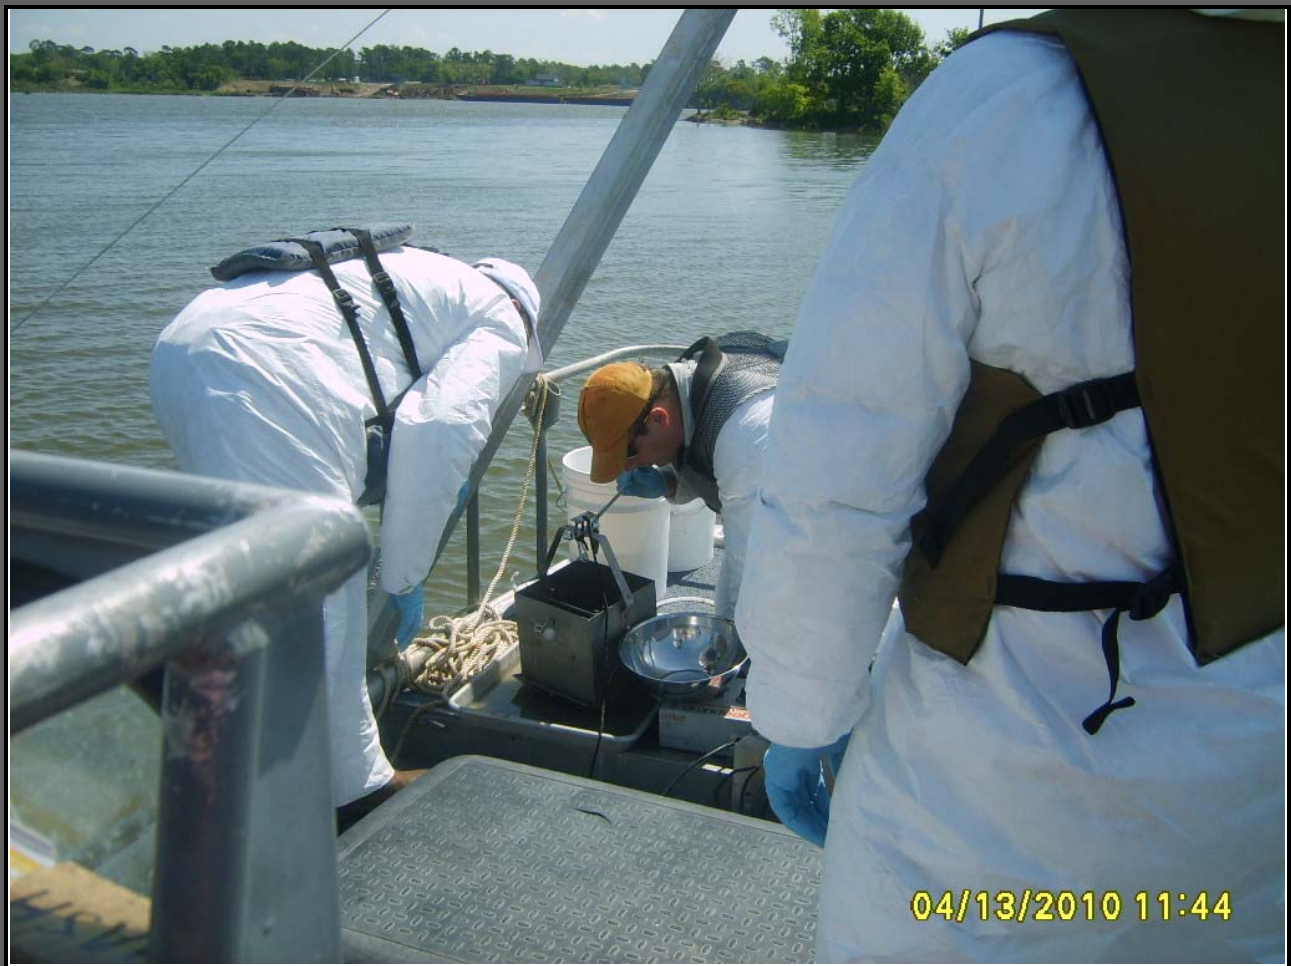
Logbook Photo #	102-0725
US EPA ID / Task Order Number	TXN000606611 / TO-0002-10-03-02
Site	San Jacinto River Waste Pits
Location Address	29.7944 N, 95.0625 W
City, State, ZIP code	Baytown, Texas
County	Harris
Direction/Orientation	East
Date	April 13, 2010
Time	1144 hrs
Photographer	Karen Berecz (START)
Witness	Jason Kase (PRP Contractor – Anchor QEA)
Description:	Spoonng sediment from sampling unit to bowl. Site SJA4.

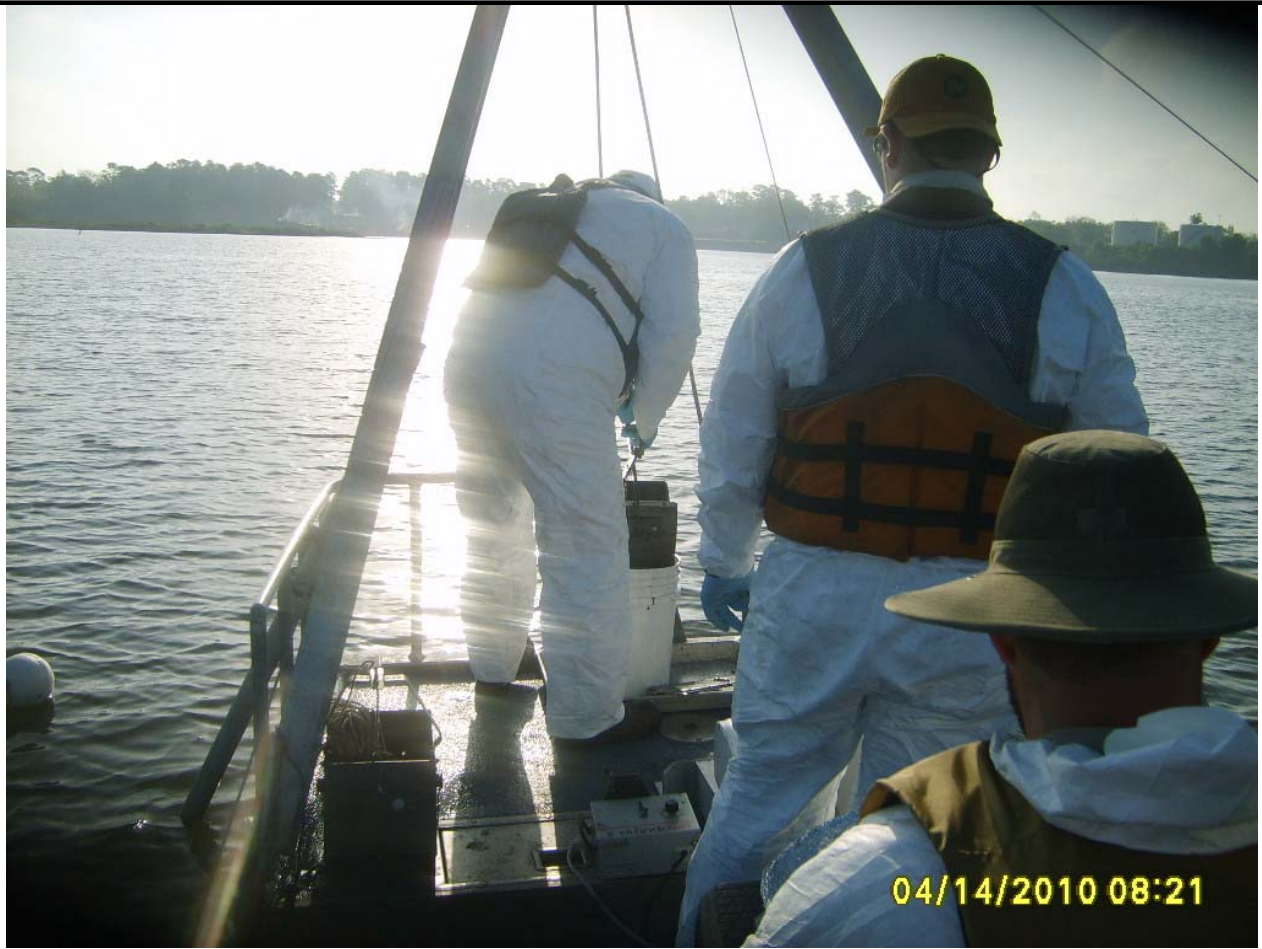
PHOTO 102-0761. LOOKING NW AT NEAL
DUMPING INADEQUATE SAMPLE FROM
PUNAR INTO 15W BUCKET, FROM SJCS

Logbook Photo #	102-0761
US EPA ID / Task Order Number	TXN000606611 / TO-0002-10-03-02
Site	San Jacinto River Waste Pits
Location Address	29.7944 N, 95.0625 W
City, State, ZIP code	Baytown, Texas
County	Harris
Direction/Orientation	Northwest
Date	April 14, 2010
Time	0821 hrs
Photographer	Karen Berecz (START)
Witness	Jason Kase (PRP Contractor – Anchor QEA)
Description:	
Dumping inadequate sample as waste into container from SJC5.

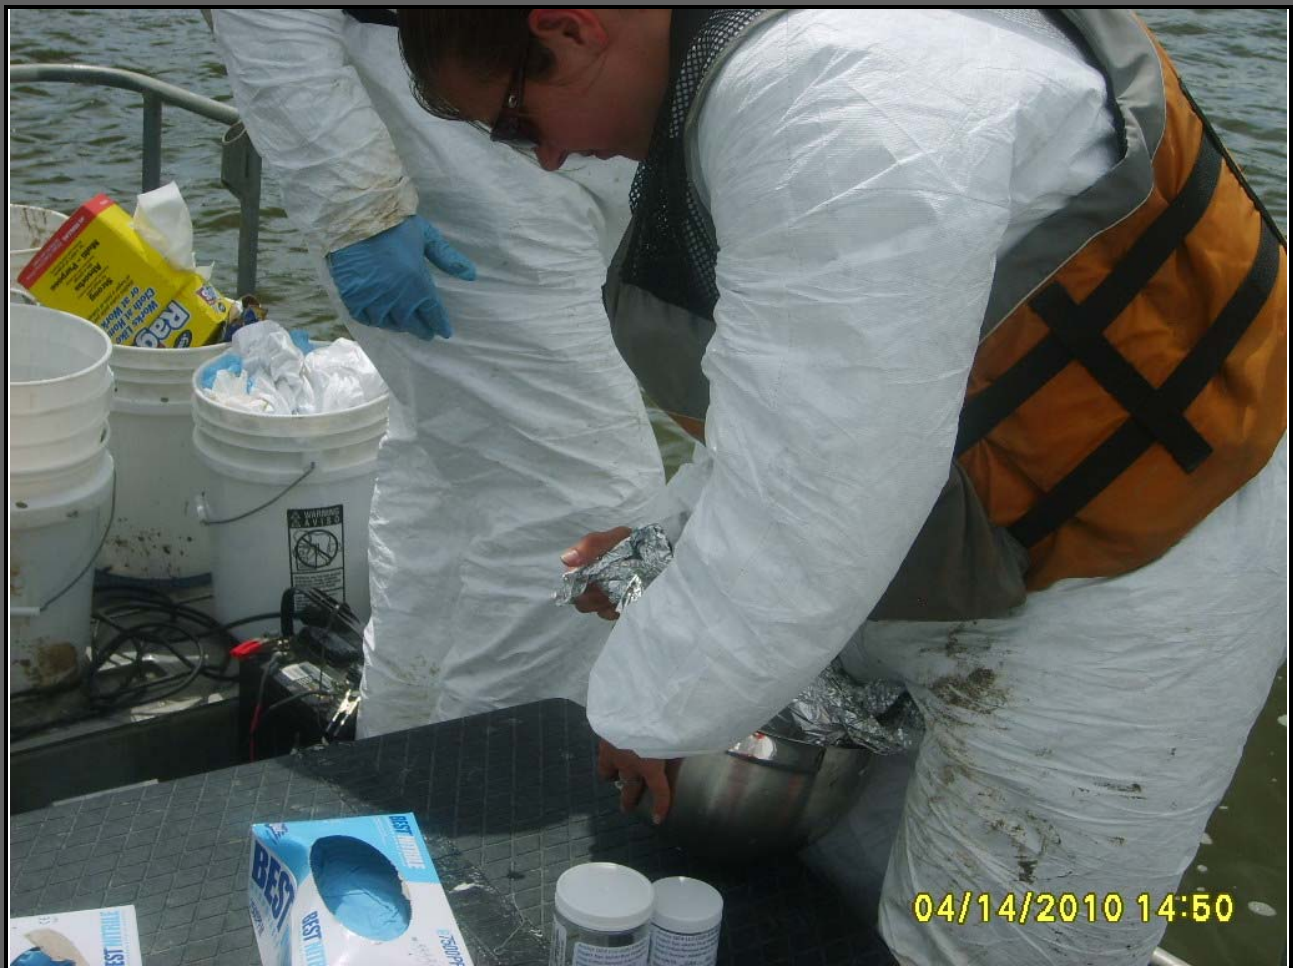
and 102-0791) shows Sarah Ballard handling a pre-cleaned, decontaminated, stainless-steel bowl and spoon without gloves worn, prior to collection of sample location SJE4. Other than the above noted and photo-documented incidents there were no other occasions of protective gear discretions.

Logbook Photo #	102-0790
US EPA ID / Task Order Number	TXN000606611 / TO-0002-10-03-02
Site	San Jacinto River Waste Pits
Location Address	29.7944 N, 95.0625 W
City, State, ZIP code	Baytown, Texas
County	Harris
Direction/Orientation	Northwest
Date	April 14, 2010
Time	1450 hrs
Photographer	Karen Berecz (START)
Witness	Jason Kase (PRP Contractor – Anchor QEA)
Description:	
Unwrapping bowl for sampling of SJE4.

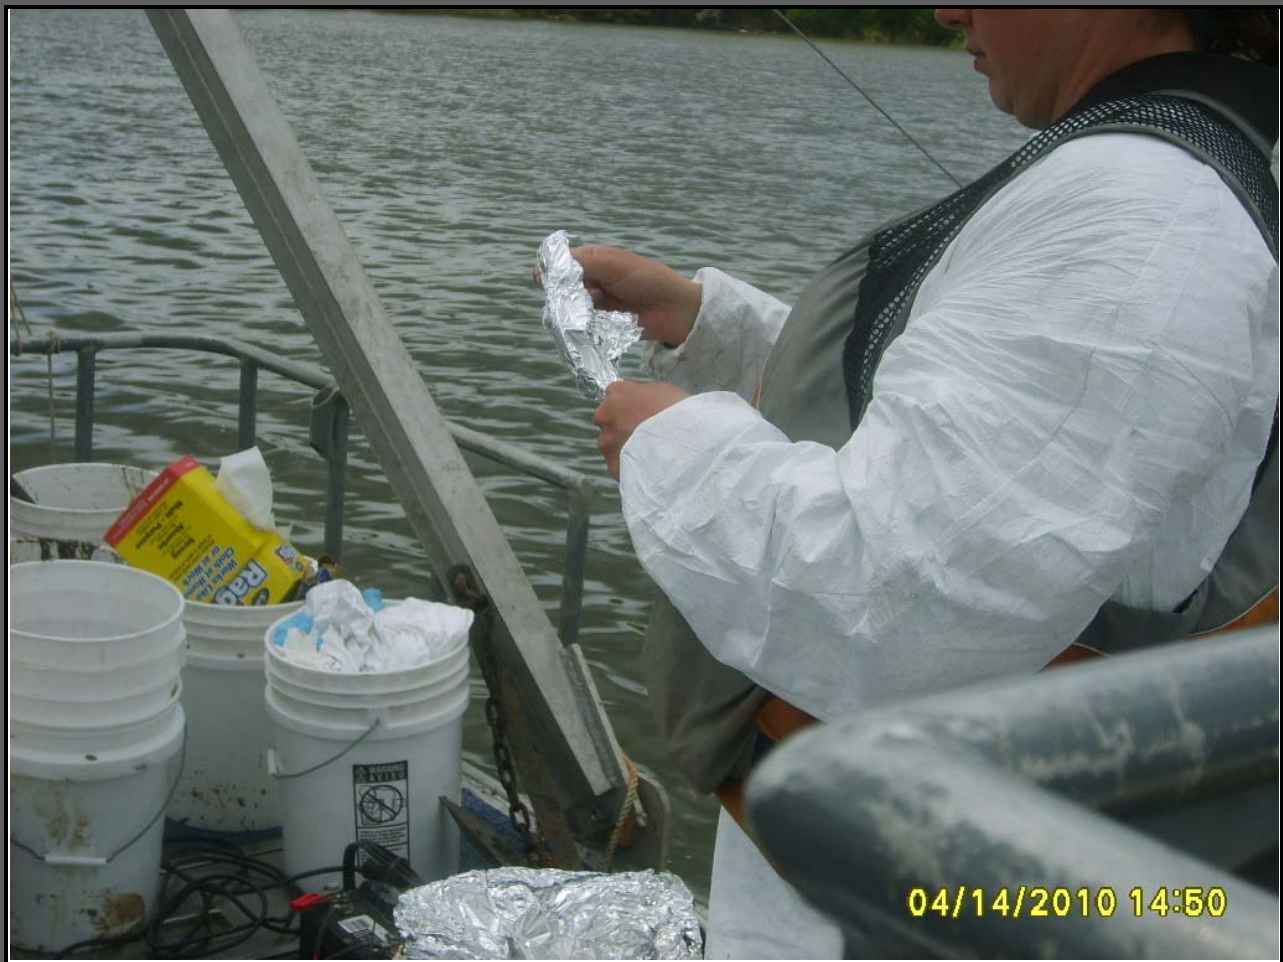
Logbook Photo #	102-0791
US EPA ID / Task Order Number	TXN000606611 / TO-0002-10-03-02
Site	San Jacinto River Waste Pits
Location Address	29.7944 N, 95.0625 W
City, State, ZIP code	Baytown, Texas
County	Harris
Direction/Orientation	Northwest
Date	April 14, 2010
Time	1450 hrs
Photographer	Karen Berecz (START)
Witness	Jason Kase (PRP Contractor – Anchor QEA)
Description:	
Unwrapping clean spoon for sampling of SJE4.
